7 September 2004

INFORMATION PAPER

SUBJECT: Updated Visual Assessment of Karshi-Khanabad (K2) Airbase, Karshi, Uzbekistan

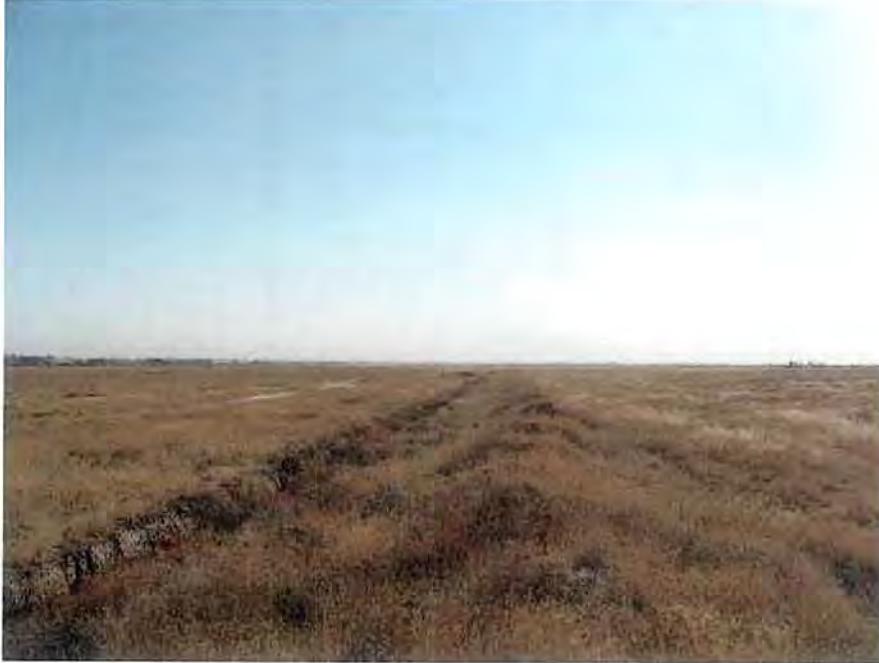
b. (U) (~~S~~) South Area. This area is mostly flat, rutted land covered with wild grass and populated by foxes, numerous rodents (most likely gerbils), and possibly snakes (see Appendix B, Figures 1 and 2). The area is intersected by some off-road vehicle trails and two (2) anti-wheeled vehicle trenches that run parallel to the airbase's existing aircraft runway. No waste disposal sites or previous industrial operations were noted in this area; however, the site does contain one (1) or more Uzbeki military guard posts (with armored personnel carriers) and a former US encampment (possibly a Patriot missile site), as noted by some discarded MRE pouches. The visual assessment team surveyed the area for potential radiological and VOC contamination, and no measurements above normal background concentrations were noted. The team collected three (3) composite soil samples and one (1) radiological soil sample during the assessment. Based on this visual assessment, the greatest potential environmental health threats in this area are infectious diseases transmitted by rodents, rabid foxes, and poisonous snakes.

Figure 1. East view of South Area with anti-wheeled vehicle trench in foreground.

b. (U) South Area. Can build within this area; however, integrated pest management services may be required to control the rodent population. Once rodents are controlled, the foxes and poisonous snakes will not present a significant health threat due to the reduced food source.

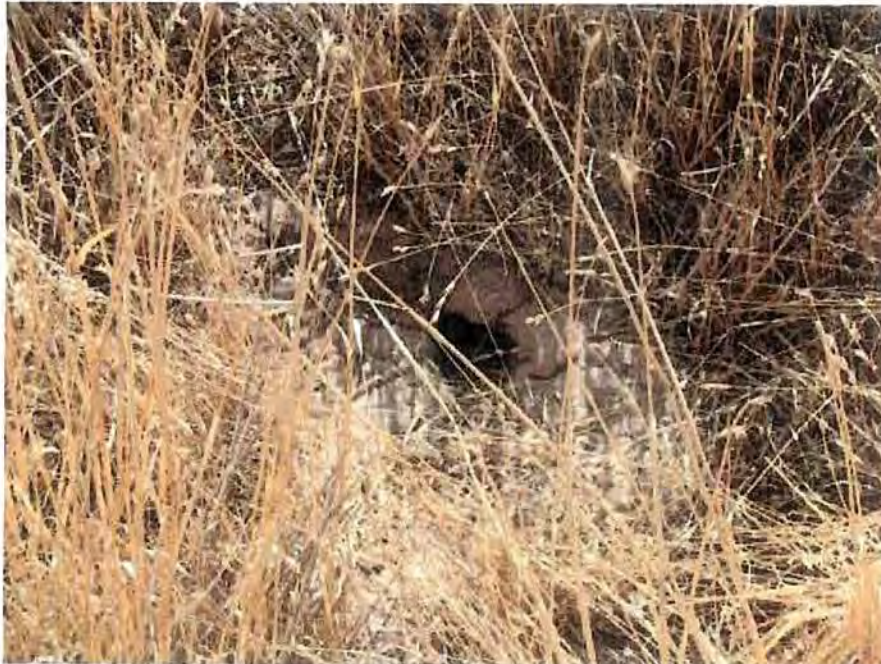
Figure 2. Rodent burrow located in South Area.

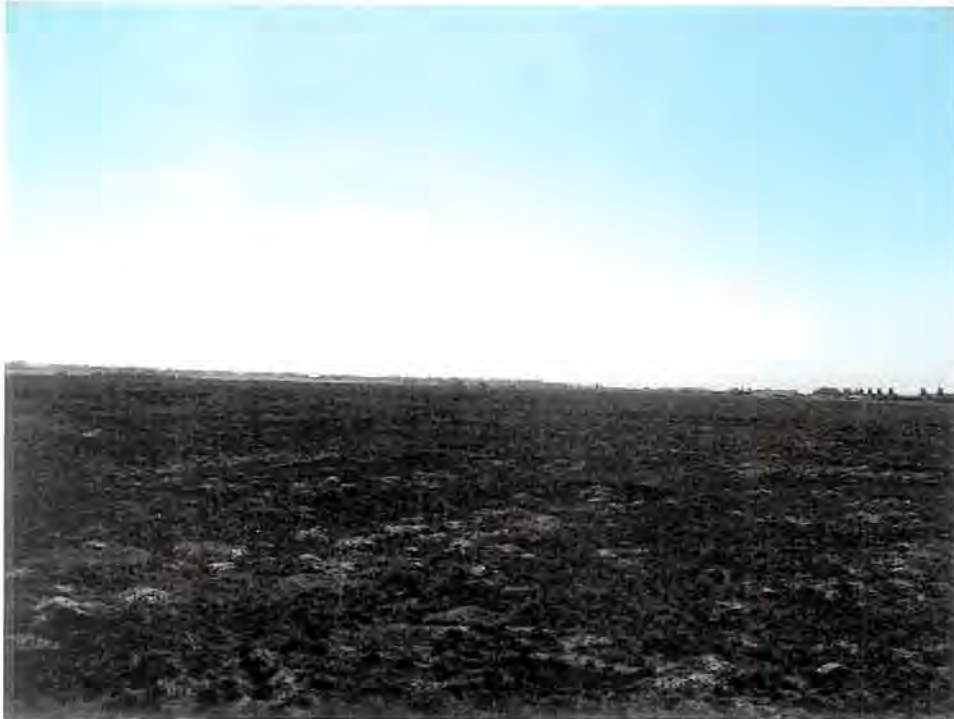
c. (U) (~~S~~) Northwest Area. This area is an open field located between the Uzbeki Air Force's hardened aircraft shelters (HASs) and the airbase's existing aircraft runway. At the time of the assessment, all vegetation in this field was burned off and no wildlife was present (although the area contained a large number of rodent burrows) (see Appendix B, Figures 3 and 4). No waste disposal sites or previous industrial operations were noted in this area; however, this site contained a US military-operated radar system enclosed by earthen berms to support the airbase's flight operations. A member of the 253rd Engineer Detachment excavated a pit approximately 6 feet in depth at vic 41S QD 53444 02459 to identify any potential POL contamination from the airbase's adjacent POL farm (see Appendix B, Figures 5 and 6). No

Figure 3. West view of Northwest Area with burned off vegetation in foreground.

c. (U) Northwest Area. Can build within this area; however, hazardous noise damping measures may be required to control aircraft maintenance, taxiing, and runway operation noise.

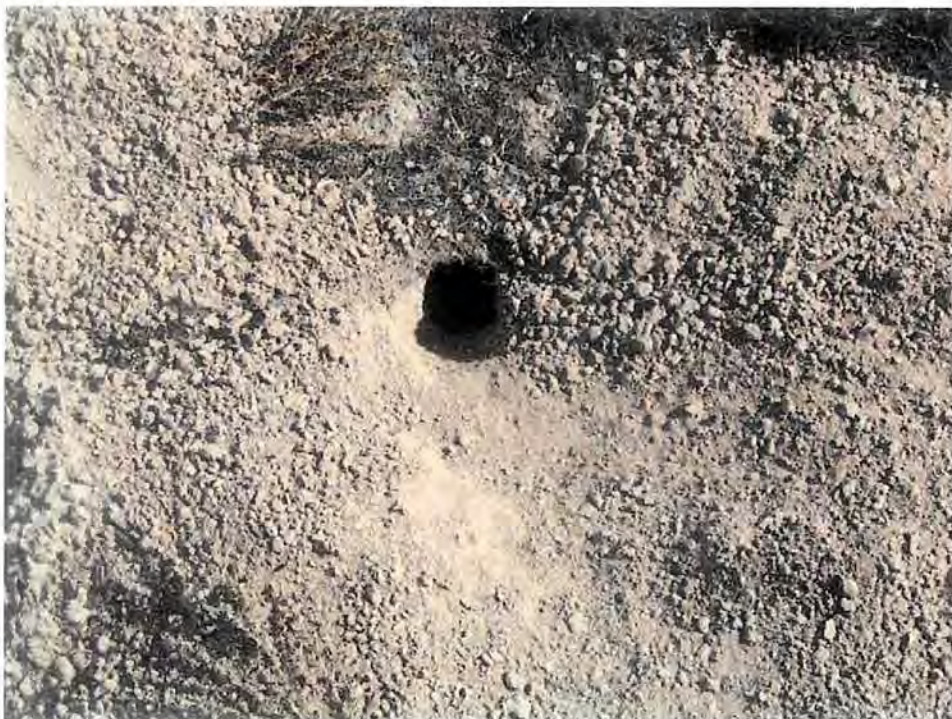
Figure 4. View of rodent burrow in Northwest Area.

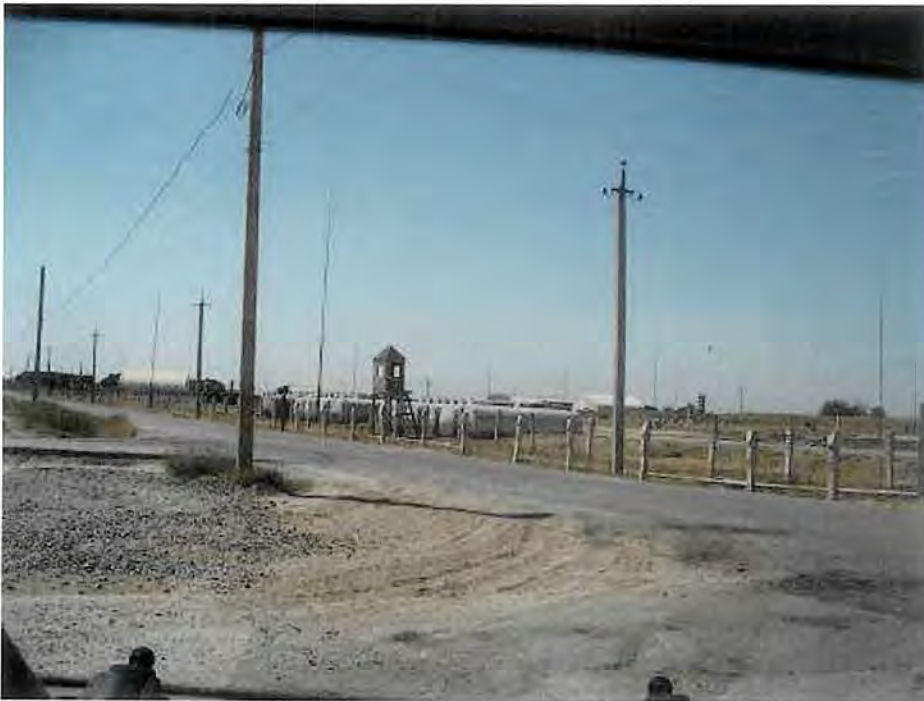
visible POL contamination or VOC vapors were noted in this pit. The visual assessment team surveyed the area for potential radiological contamination, and no measurements above normal background concentrations were noted. The team collected one (1) composite and one (1) subsurface soil sample during the assessment. Based on this visual assessment, the greatest potential occupational and environmental health threats in this area are hazardous noise, as well as exhaust gases and fumes, from adjacent aircraft maintenance, taxiing, and takeoff/landing operations.

Figure 5. View of POL farm located on Uzbeki Air Force portion of K2 Airbase.

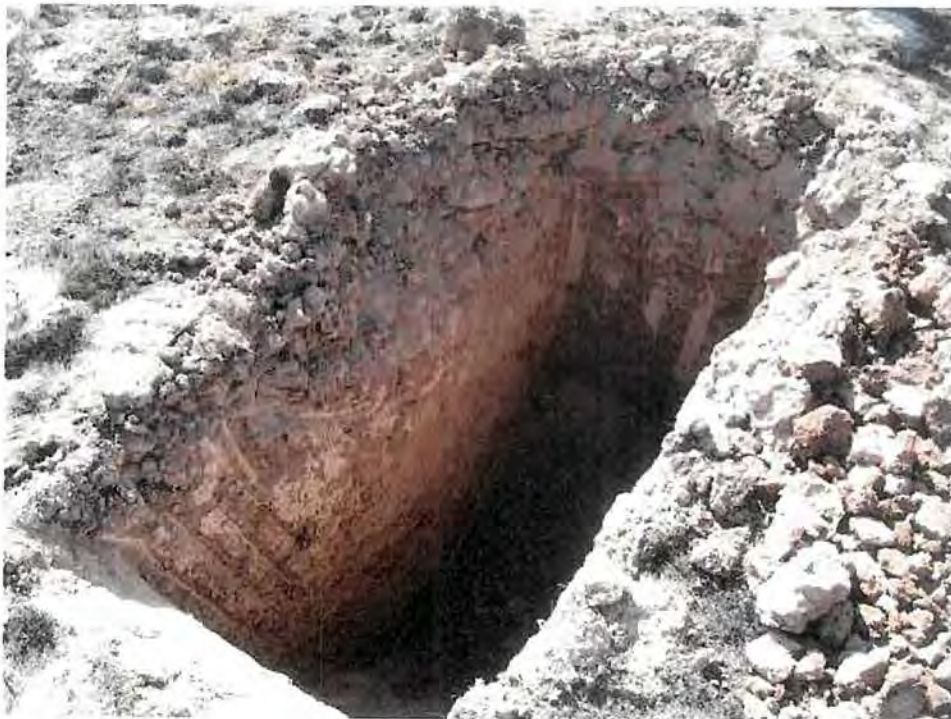
Figure 6. View of 6-foot excavation pit dug in Northwest Area by 253rd Engineer Detachment.

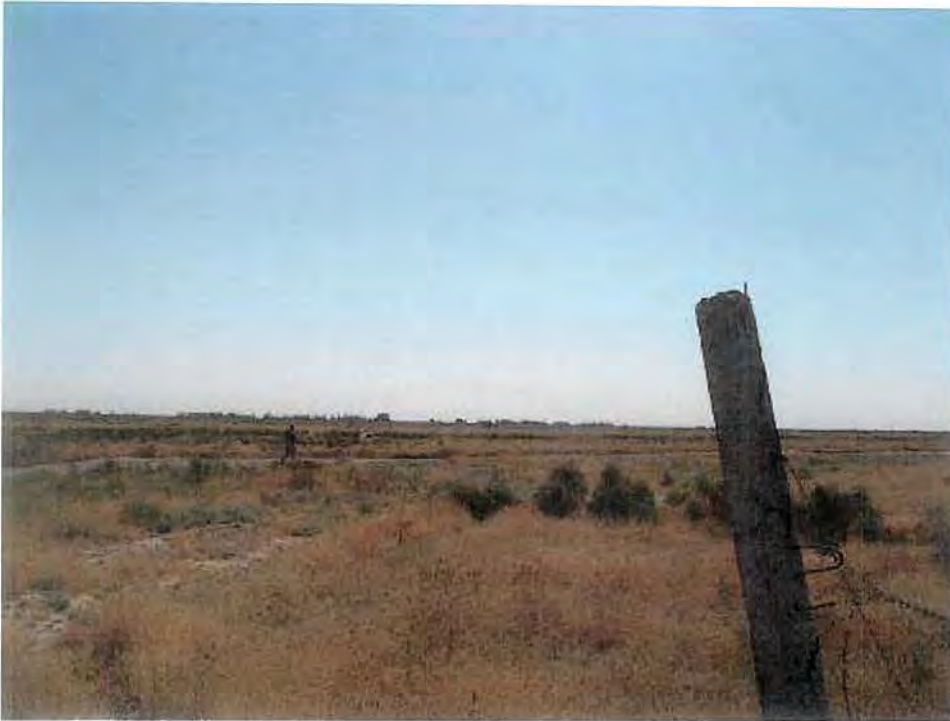
e. (U) (~~S~~) East Runway Area. This area is a former cultivated field (most likely cotton) containing two (2) parallel fence lines (one barbwire fence at the extreme end of the existing aircraft runway vic 41S QD 55220 02876 and one concrete fence along the airbase perimeter vic 41S QD 56054 03024) (see Appendix B, Figure 7). These fences are approximately 500 meters apart from one another and are perpendicular to the existing runway. A local village is located on the northeast corner of the airbase. No waste disposal sites or previous industrial operations were noted in this area; however, a number of Uzbeki military guard towers were noted along the interior of the airbase's perimeter. Based on this visual assessment, the greatest potential occupational and environmental health threats in this area are hazardous noise, as well as exhaust gases and fumes, from aircraft takeoff and landing operations.

Figure 7. Southeast view of East Runway Area with barb wire fence in foreground.

e. (U) East Runway Area. Can build within this area; however, hearing protection may be required to reduce aircraft runway operation noise.

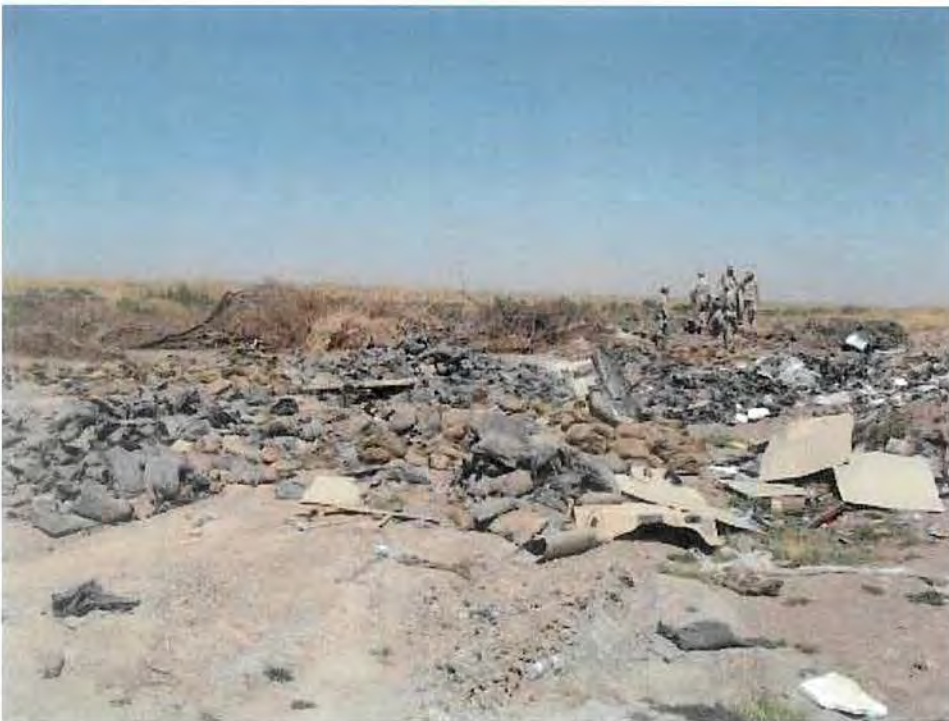
f. (U) (~~S~~) Setback Area. This area is similar to the South Area except that it is located on the southern and southeastern boundary of the South Area. No previous industrial operations were noted in the area; however, a solid waste disposal site and numerous Uzbeki military guard towers were noted in this area (see Appendix B, Figure 8). The visual assessment team surveyed the area for potential radiological and VOC contamination, and no measurements above normal background concentrations were noted. Based on this visual assessment, the greatest potential environmental health threats in this area are infectious diseases transmitted by rodents, rabid foxes, and poisonous snakes.

Figure 8. Solid waste disposal area located in Setback Area.

f. (U) Setback Area. Can build within this area with some remediation. The solid waste disposal site should be cleaned up, and integrated pest management services may be required to control the rodent population. Once rodents are controlled, the foxes and poisonous snakes will not present a significant health threat due to the reduced food source.
